**California Public Utilities Commission
Consumer Protection and Safety Division**

**Investigation of Southern California Edison Company's Outages of
November 30 and December 1, 2011**

**PRELIMINARY REPORT
February 1, 2012**

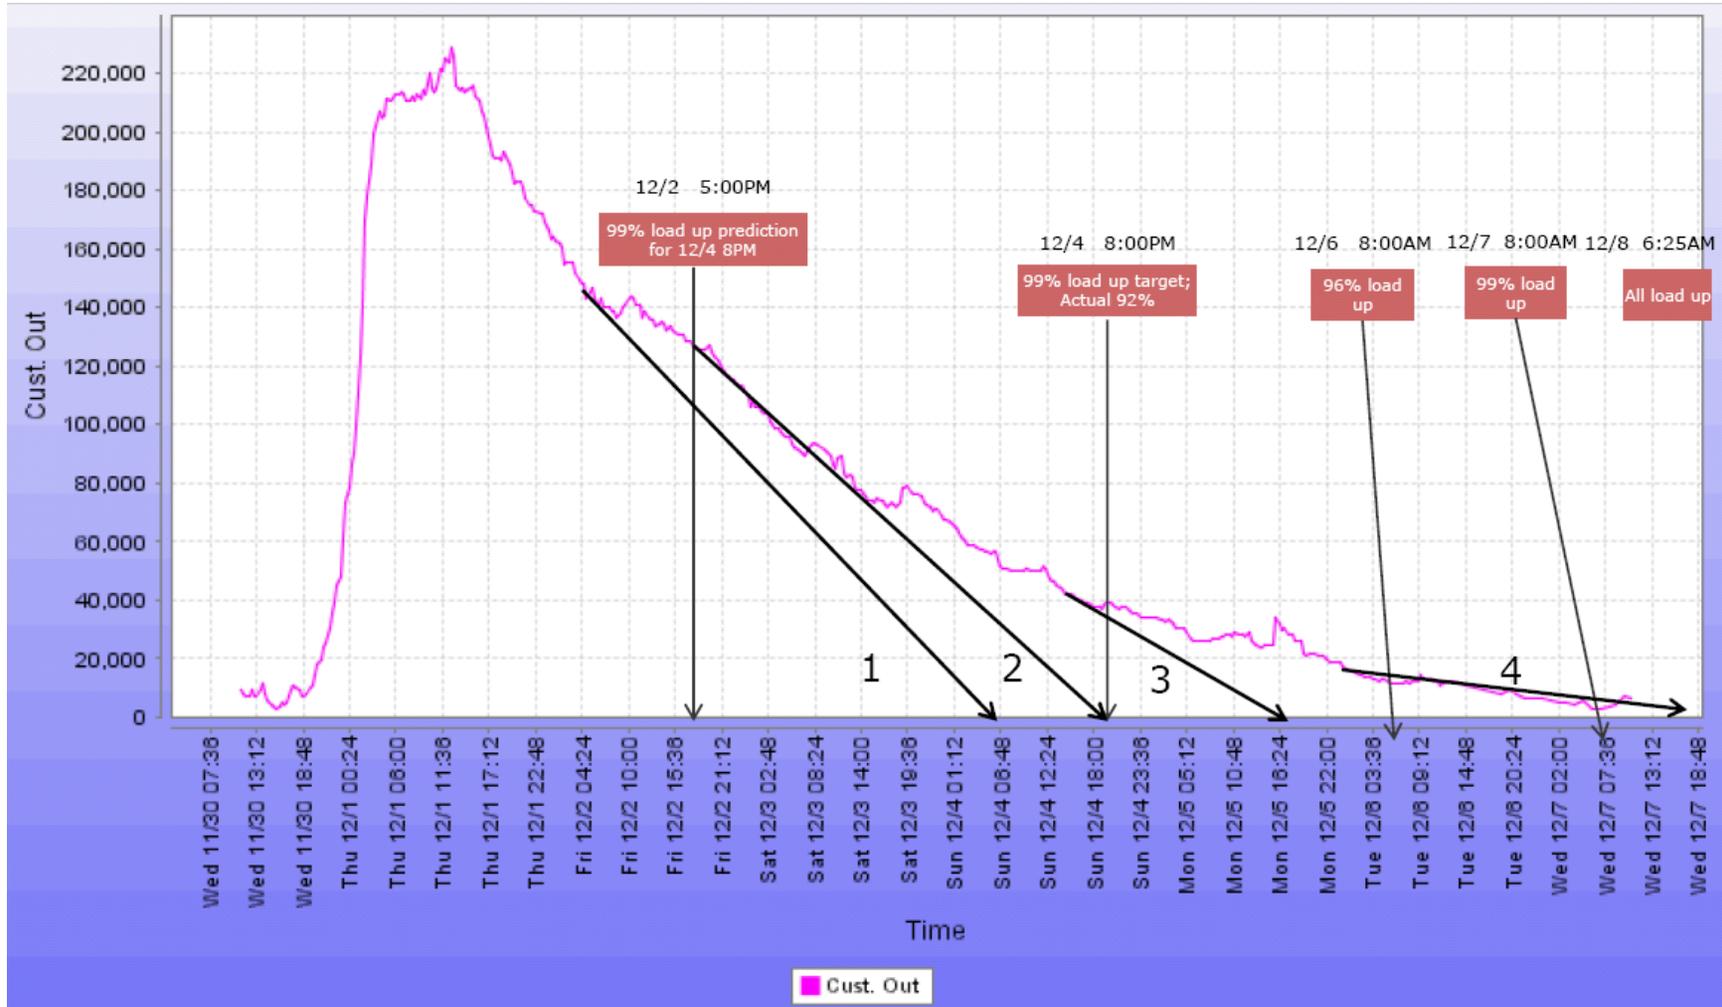
Figure 1
SCE's Restoration Estimates

Inaccurate power restoration time estimates were a major issue during the incident. Lars Bergmann, Managing Director of SCE's Distribution Business Line, reported that early in the repair process, SCE field personnel estimated completion time based on fully evaluated circuit damage or actual work in progress, and SCE passed these estimates to the public through the OMS database. Mr. Bergmann reported that these predictions tended to be correct. However, Mr. Bergmann further explained that for less accessible repairs, he extrapolated from early or historical outage restoration experience to produce general estimates. Using these estimates for the windstorm proved overly optimistic, particularly for the more difficult or isolated repairs. Figure 1, titled, *SCE's Restoration Estimates*, shows the overly optimistic restoration projections.

The diagonal black arrows represent SCE's restoration estimates, and the pink curve represents the number of customers without power.

Accurate, conservative estimates coupled with frequent communication empower customers to plan alternative accommodations and make adequate arrangements in the event of protracted outages. SCE should ensure it provides accurate estimated restoration time to its customers. In keeping with this goal, CPSD recommends that SCE analyze the accuracy of restoration time estimates during the incident and make changes accordingly. SCE should implement in-person "door-to-door" outreach activities during emergencies.

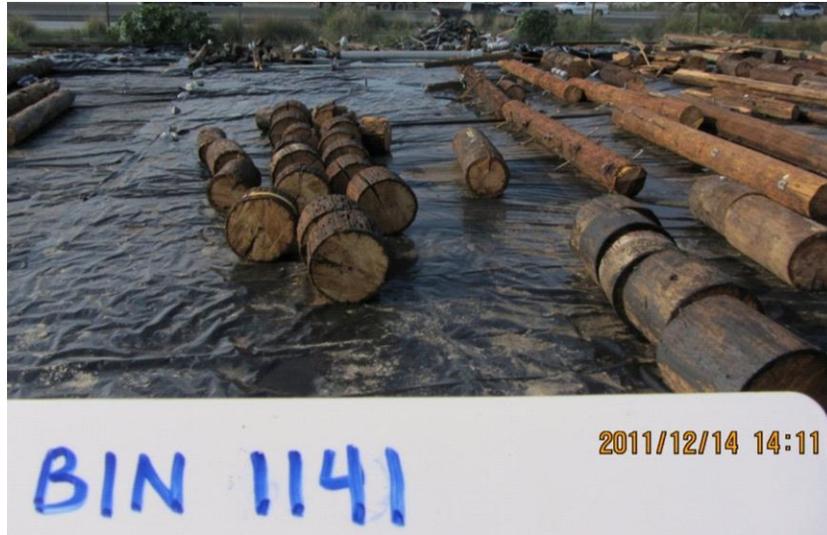
- Poles were cut into segments, which in some cases were very small, such as 80 foot poles cut into 8-10 inch pieces (see Figures 1 and 2 below)
- Often times, segments belonging to one pole were scattered throughout various bins, increasing the difficulty and decreasing the likelihood of identifying matching segments
- Many poles had missing segments, making complete reconstruction of the failed pole impossible
- Pole segments, for the most part, were not catalogued in any discernible manner, making it nearly impossible to determine which failed pole they belonged to and exponentially increasing reconstruction time

Figure 2
One pole cut into numerous small segments

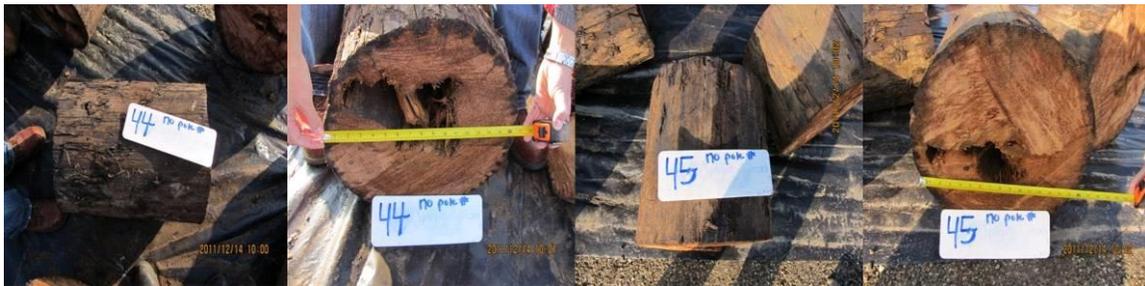
Figure 3
Examples of small individual pole segments

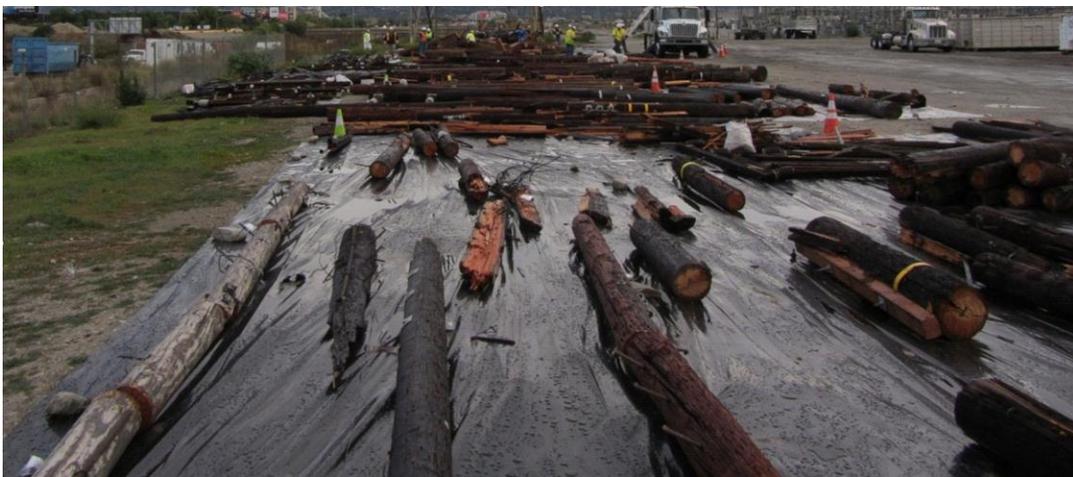
The failed poles that were preserved by SCE were taken to SCE’s Rio Hondo substation so that CPUC engineers could reconstruct the poles. These efforts were immensely hindered by the nature of SCE’s collection and cataloguing methodology. Of the nearly 200 poles that failed, partial segments of only roughly 60 poles were collected and delivered to the Rio Hondo substation for analysis by CPUC engineers.¹³ The remaining poles were discarded by SCE staff. Of the poles provided by SCE, CPUC engineers were only able to completely reconstruct five failed poles. Factors impeding the reconstruction and assessment of these poles included the following:

Figure 4
Portion of pole segments at Rio Hondo substation

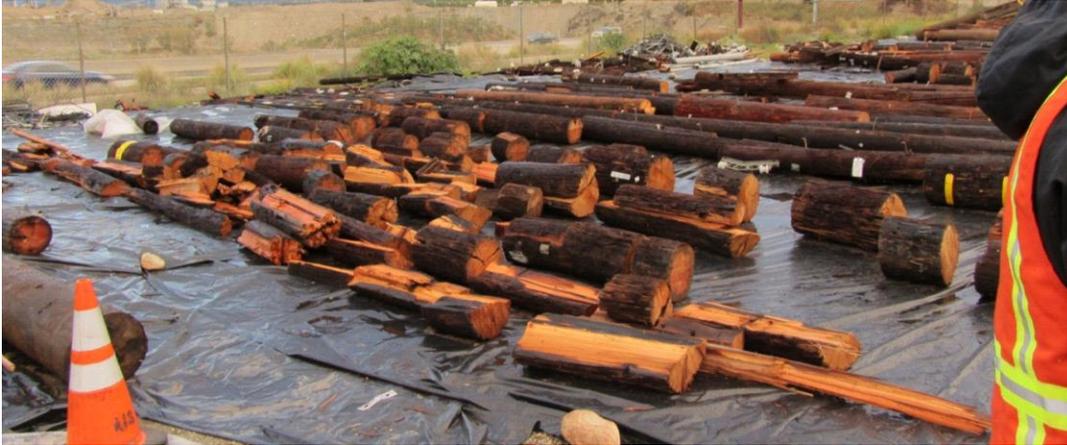
Figure 5

Small pole segments laid out for reconstruction at Rio Hondo substation
